# **Soil Freeze–Thaw Effects on Bank Erosion and Stability: Connecticut River Field Site, Norwich, Vermont**

Michael G. Ferrick, Lawrence W. Gatto,  
and Steven A. Grant

December 2005

*U.S. Army Engineer Research and Development Center  
Cold Regions Research and Engineering Laboratory (CRREL)  
Hanover, NH 03755-1290*

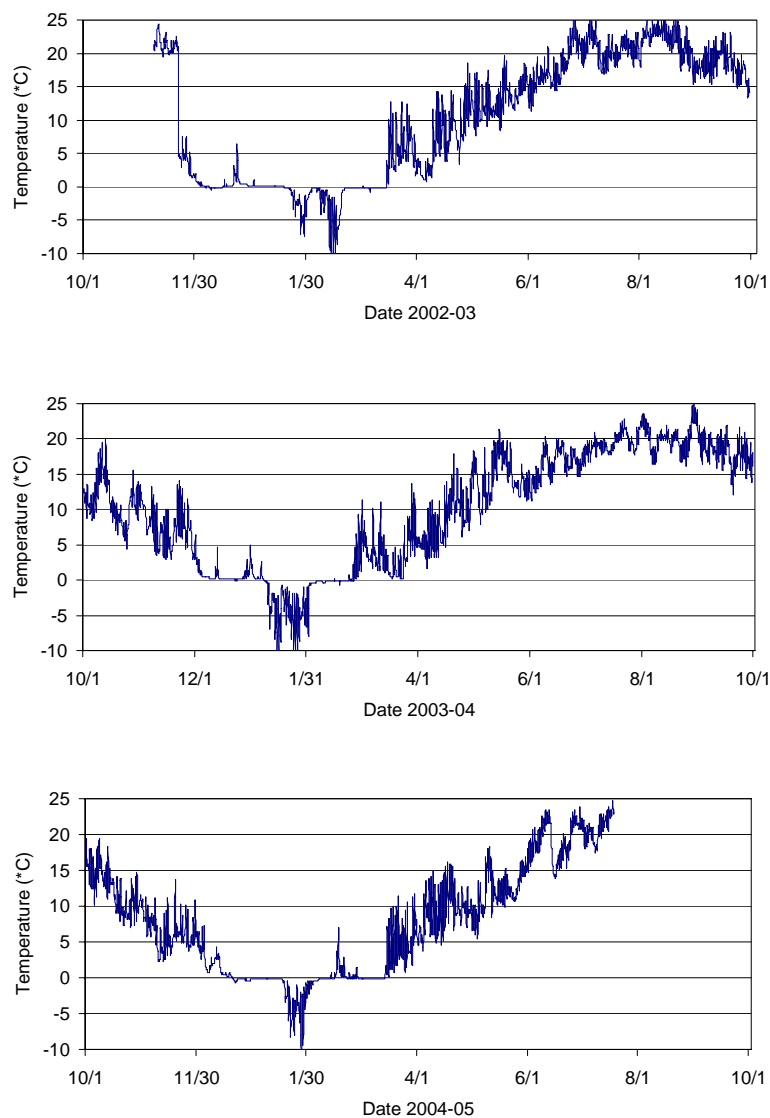
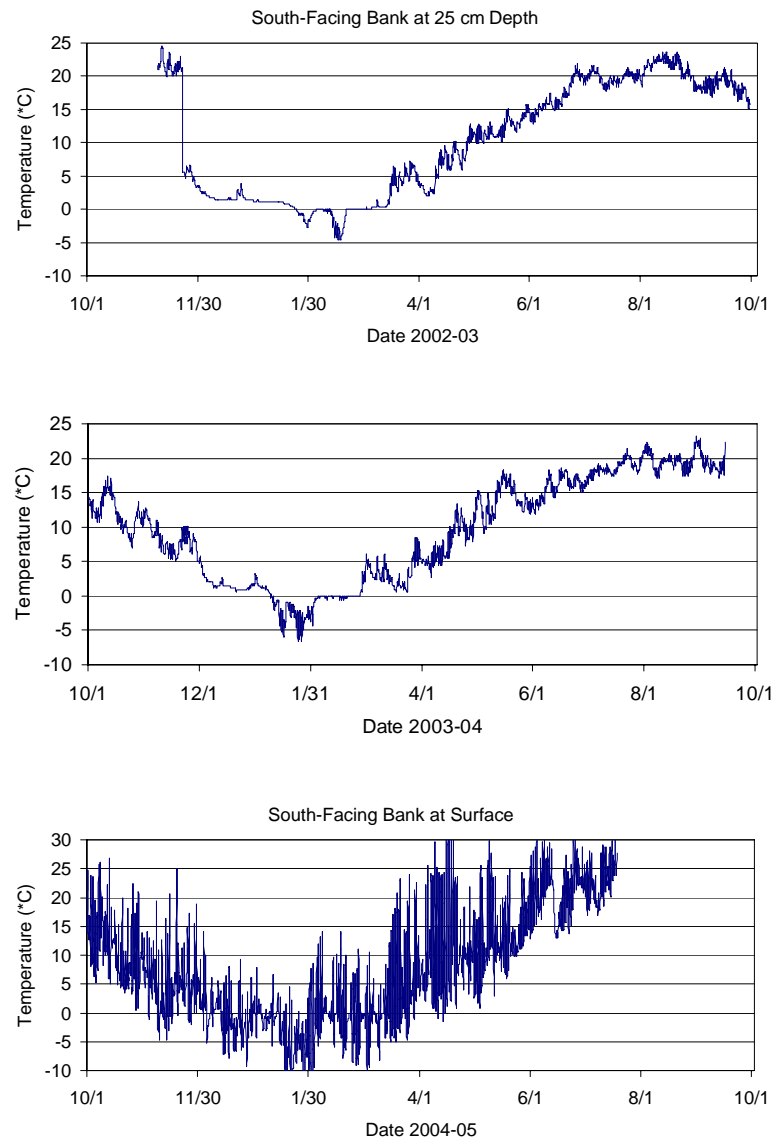
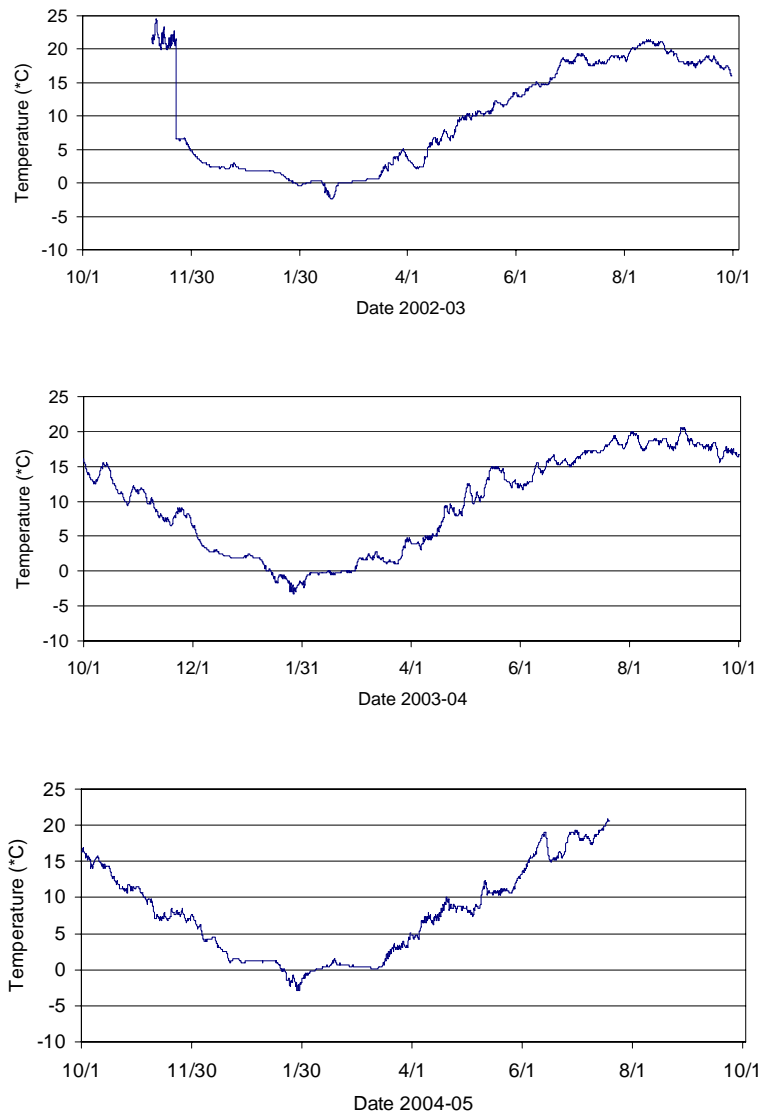
**Figure 26. Soil temperature (°C) at 10-cm depth in the south-facing bank.**

**Figure 27. Soil temperature (°C) at 25-cm depth and at the surface of the south-facing bank.**

**Figure 28. Soil temperature (°C) at 50-cm depth in the south-facing bank.**

Corresponding soil temperatures of the south-facing bank are given in Figures 26, 27, and 28 for the 10-, 25-, and 50-cm depths. As might be expected, the north-facing bank recorded the lowest soil temperatures and the longest FT durations, exceeding 4 months at shallow depths. In contrast, the south-facing bank site had freezing durations always less than 2 months. The north-facing bank had almost no diurnal soil temperature variations, while the south-facing bank site had by far the most pronounced diurnal temperature fluctuations of any monitored bank. These fluctuations were large at 10 cm (Fig. 26) and still visible at 25

cm (Fig. 27). The 25-cm sensor at the south bank site was pulled by a curious member of the public in 2004–05 and placed on the surface. The result was extremely large temperature fluctuations that approach those of the air temperature.

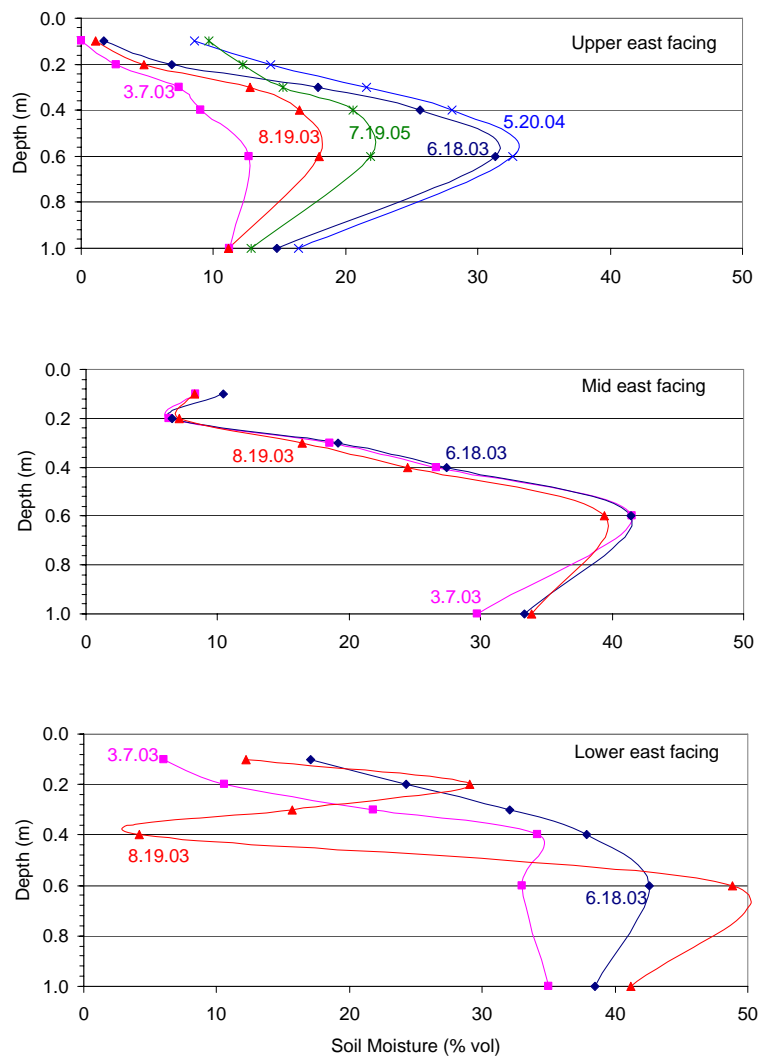
**Figure 29. Soil moisture profiles through time on the east-facing bank at the “instrument” profile line near top, mid-, and bottom.**

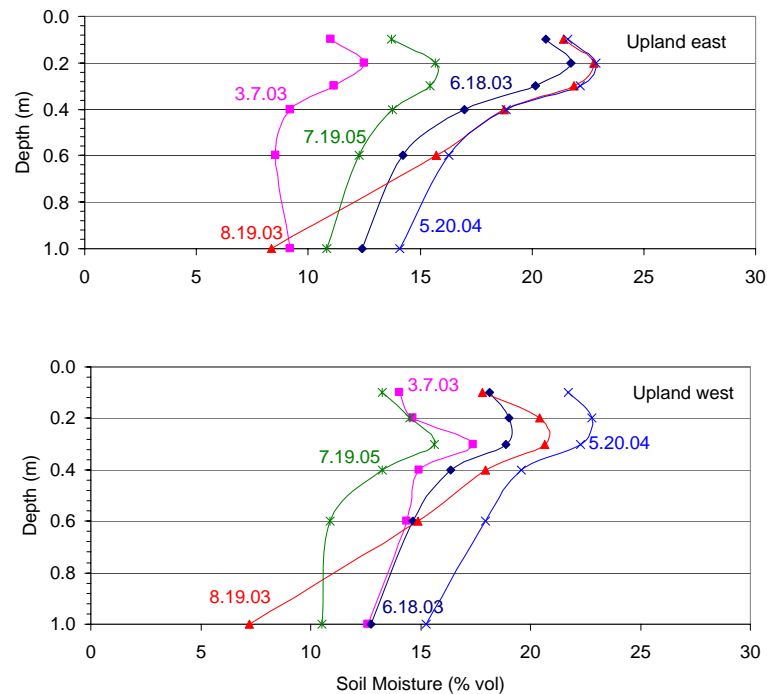
**Figure 30. Soil moisture profiles through time of the upland surface on the “instrument” profile line, east and west.**

Upland soil moisture profiles on the instrument line, given in Figure 30, are consistent with each other and through time. These profiles show lower soil moistures than on the slope, peak moisture consistently between 0.2 and 0.3 m, and minimum soil moisture at 1 m depth. Upland soil near the bank crest is generally drier with less seasonal variation than soil below the crest. Figure 31 presents soil moisture profiles through time for the upper and mid-north-facing bank. Soil moisture of the upper slope is uniform and relatively low through the 1-m depth. A seasonal trend can be discerned, with wetter soil in the spring, drying into the summer. Soil of the mid-north-facing bank is relatively dry in the upper 0.2 m, becoming wetter and more uniform below the 0.3-m depth. This profile also shows seasonal trends, dryer in late winter and summer and wetter in spring. Similar to the instrument profile line of the east-facing bank, the soil of the upper north-facing bank is drier than that of the mid-bank. Overall, the north-facing bank is drier than the instrument line of the east-facing bank, possibly a result of more dense vegetation or local differences in soil composition.

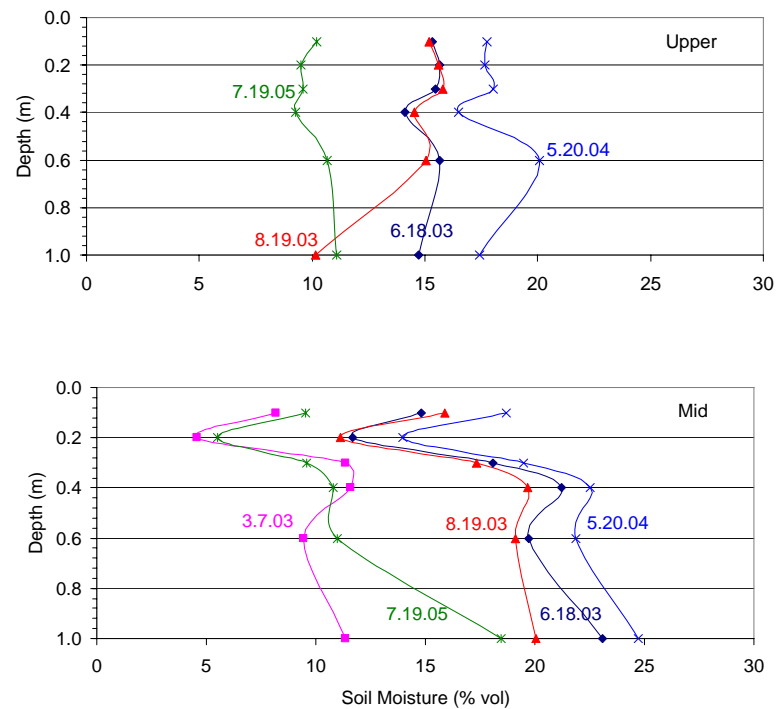
**Figure 31. Soil moisture profiles through time of the north-facing bank, upper and mid-.**

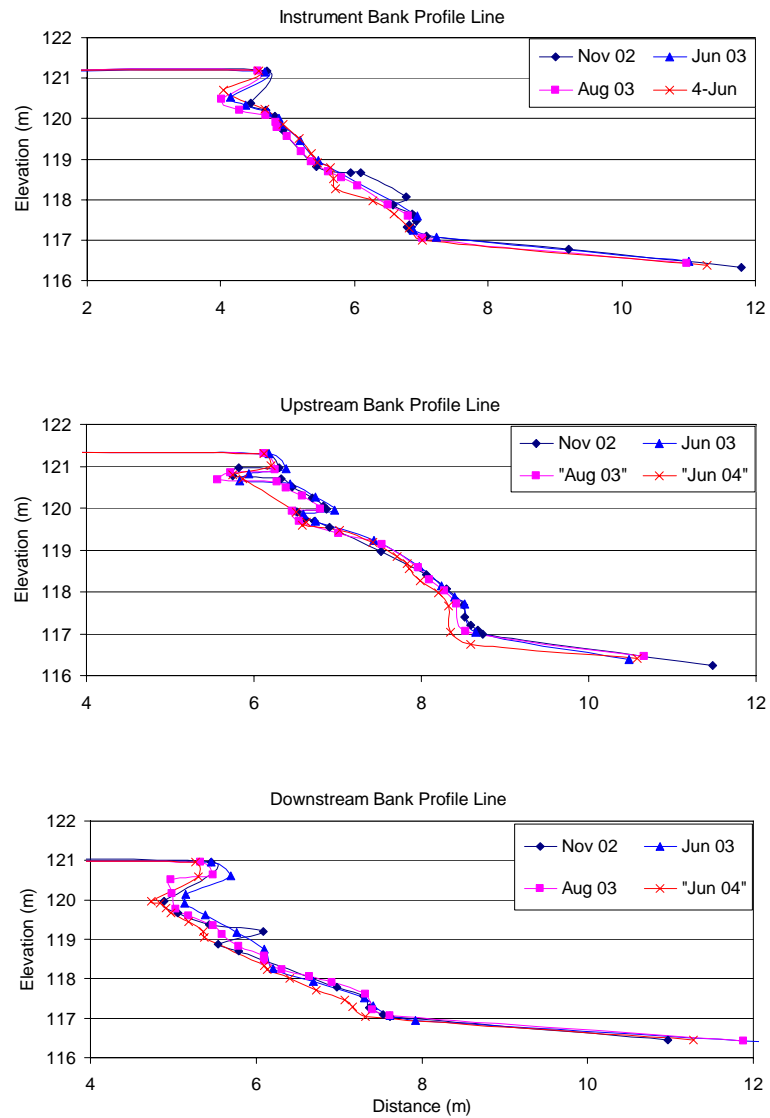
**Figure 32. Repeat surveys through time of instrument, up-stream, and downstream bank profile lines.**

Four surveys of the profile lines on the east-facing bank were conducted between November 2002 and June 2004, with results presented in Figures 32 and 33. The profile changes through time shown in Figure 32 indicate banks that are undergoing surface erosion, not failure along deeper planes of weakness, and give a sense for the times when these changes occurred. However, loss of access to mid- and lower east-facing slope soil moisture tubes at the instrument line indicates some deeper soil movement. Cavity development near the top of the bank on this same line can be noted in these survey results and has continued in 2005. These surficial bank changes validate the importance of the surface property measurements obtained. Banks that are frozen in winter and subject to minimal precipitation in summer should not erode during those periods. The most probable periods for bank erosion are during fall prior to the freeze, and during the spring following thaw. Small bulges in each profile line that disappeared over the FT season indicate a likely role of FT in the surficial upland erosion of the bank.

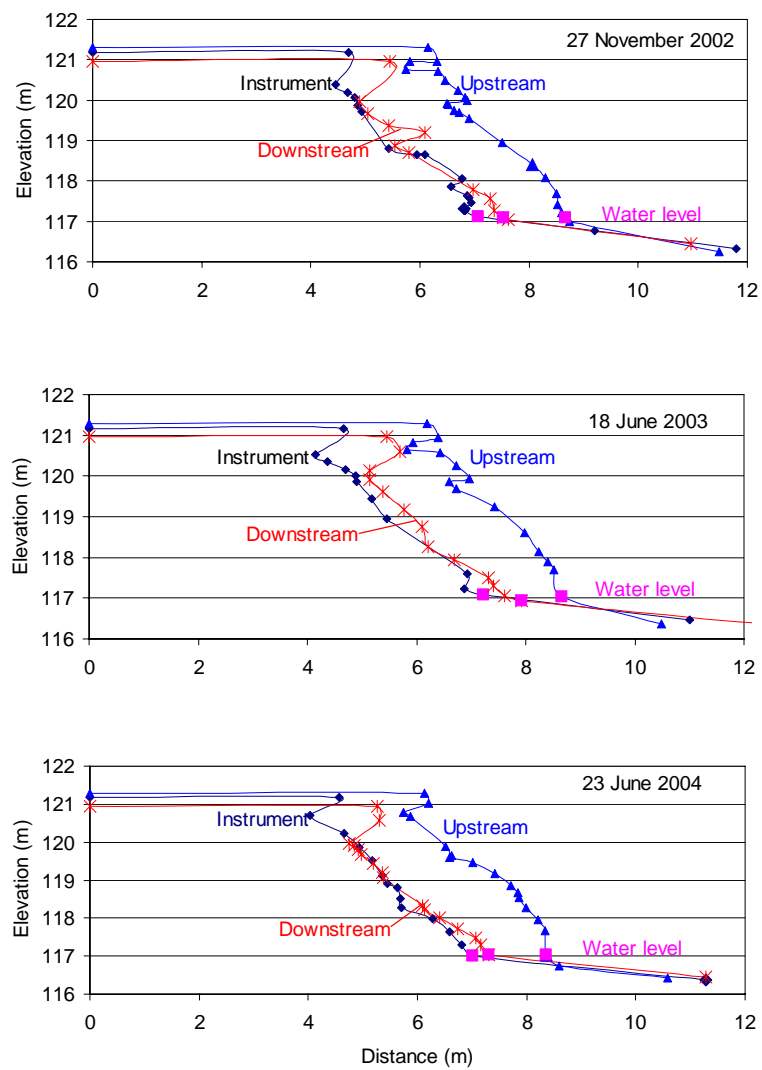
**Figure 33. Instrument, upstream, and downstream bank profile lines compared through time.**

The profile lines are compared with each other for each of the years of the study in Figure 33. In this form the changes along each profile can be more readily discerned, and similar average slopes are evident. Bank recession has proceeded steadily along all three profiles, and slope similarities are maintained through time despite variable soil characteristics and large differences in density of the vegetative cover. These similarities together with significant erosion at the base of the bank (Fig. 4) indicate that a primary forcing is by hydraulic processes of the river. Waves and fluctuating water levels of Wilder Reservoir were active in removing both fine sediments and native materials from the base of the bank (Fig. 4 and 6) over the full monitored length.
